Alaska CEs Use State-of-the-Art Technology to Renew Water Mains

Mr. Hazim K. Yunis, P.E.
673 CES/CEPM

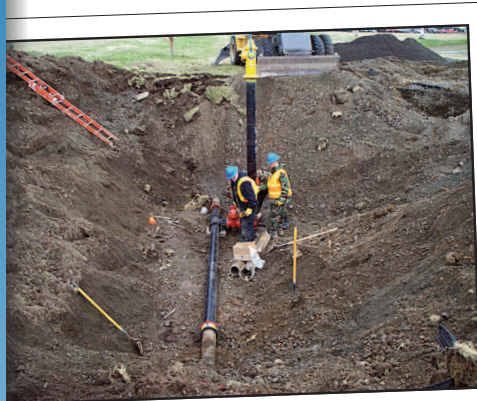
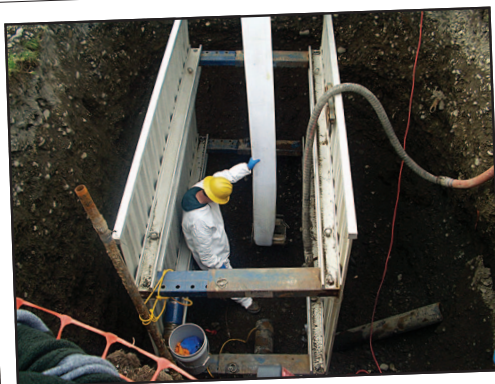
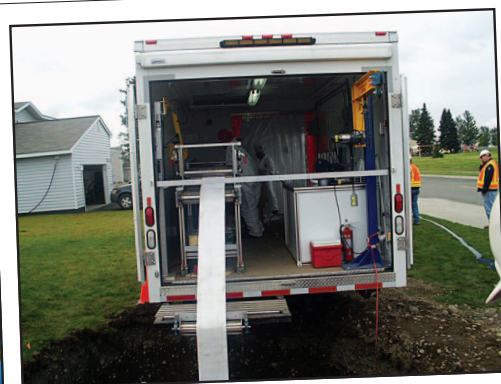
Replacing pipes using traditional (non-trenchless) methods requires 40-wide excavation (left). During pipe repair at JBER using trenchless technology, a flexible liner is impregnated with epoxy (right), then pulled into existing pipe (center). (U.S. Air Force photos)

Using the access pits, a liner was inserted (pulled) into the existing pipe. This flexible liner consists of two concentric, tubular, woven polyester jackets with a watertight polymer membrane bonded to the interior. The liner is impregnated with a resin epoxy that bonds to the interior of the existing pipe under applied heat. A foam pig pushed through the liner using water pressure shaped the liner, and then hot water was circulated through the liner to cure the resin into a hard, impermeable pipe and bond it to the existing water main. After pressure testing the liner, existing valves and hydrants were replaced with new ones and 34 service connections were reinstated from inside the pipe using special robotic equipment.
