**North American Society for Trenchless Technology (NASTT)
NASTT's 2013 No-Dig Show**

TM2-T3-01

Water Main CIPP Lining Taking-off in Anchorage

Matt Stephi, P.E.¹, Stephen Nuss, P.E.²

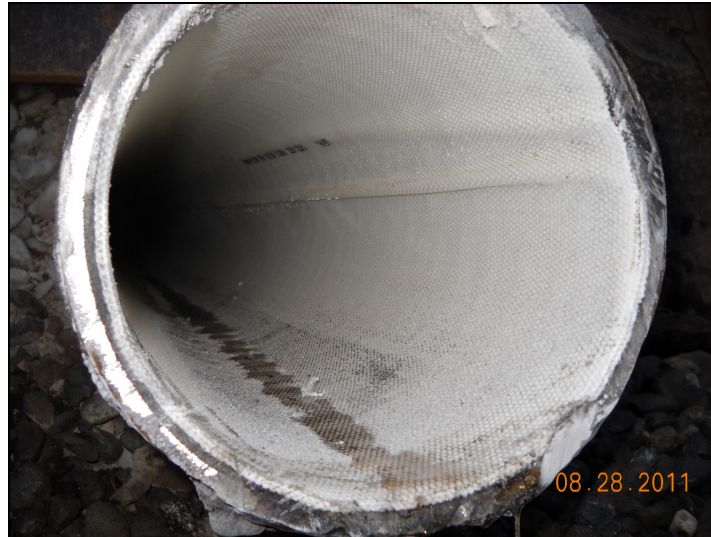
Figure 2. CIPP lined cast iron water main

Typical Standards: A new CIPP liner (Figure 2) must meet the following standards when installed in the AWWU water system:

- NSF/ANSI 61 certification.
- Fully structural liner meeting AWWA M28 Class IV.
- The liner strength and wall thickness must meet the requirements of ASTM F1216.

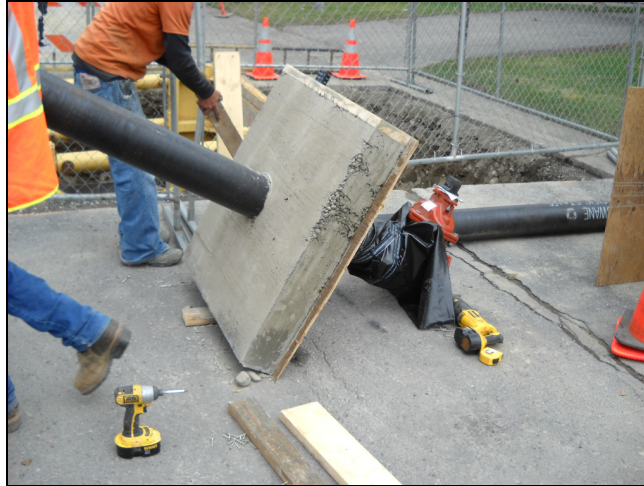
Figure 3. Thrust blocks are precast in some cases to minimize water shut-down times.

- A temporary water system must be constructed and put into use while the main is out of service.
- In an unrestrained water pipe system, new thrust blocks (Figure 3) and restraint devices are used at the CIPP project boundary to help keep the surrounding water pipe network in service and reduce the size of the temporary water system.

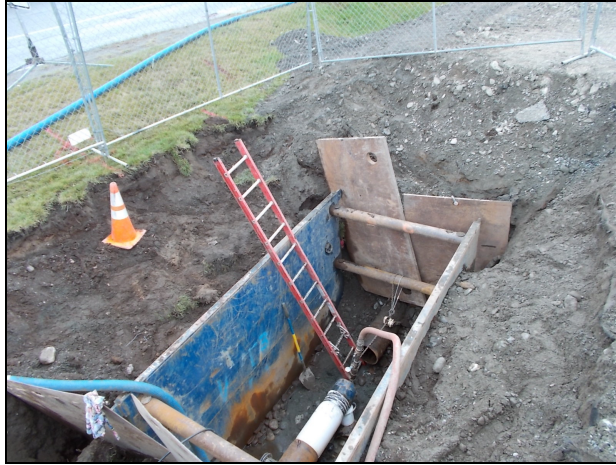
Figure 4. Typical liner access pit

- Pits are excavated to gain access to the main as shown in Figure 4. Normally the pits are spaced about 400 feet apart and are often located at tees and hydrants.

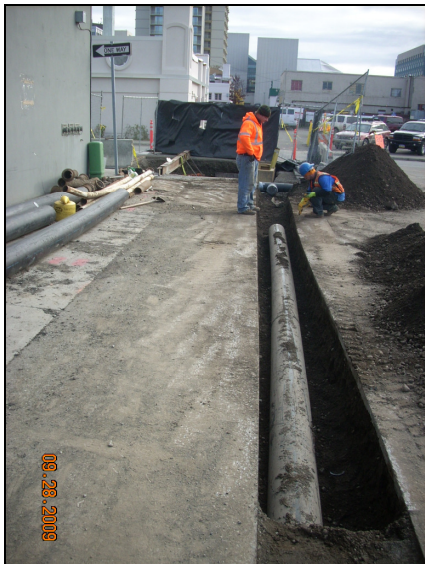
Figure 5. Buried temporary water piping in a business district.

Construction Timeline: On an Anchorage CIPP project an existing water main is usually taken out of service for six to seven days. The main will be shut off after the temporary water system is put into operation and access pit excavations are underway. Figure 5 and Figure 6 show a temporary water system under construction. Host pipe inspection and preparation are completed the first day. On day two, the new liner is inserted and cured. Day three is spent pressure testing the new liner and reinstating services robotically. On day four, the main is cleaned of service reinstatement debris and reconnected to the water system. Chlorination and disinfection can be completed on day four in some cases. In Anchorage, bacteriological testing is done twice; an initial sample is taken and then a confirmation test is done again 24 hours later. Bacteriological testing results are available on the sixth or seventh day. The successfully lined water main is put back into service after the second successful bacteriological test is received.

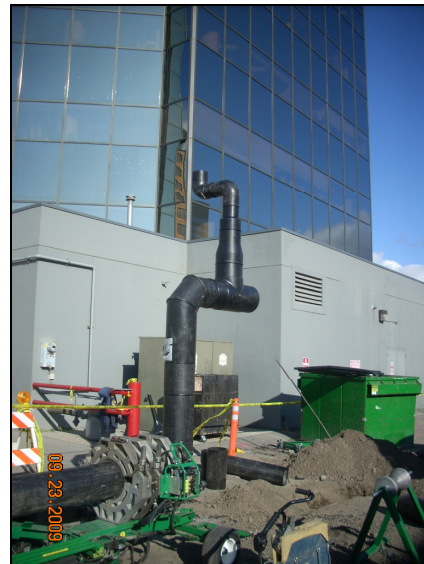
Figure 6. Elaborate pipe for a fire-flow sized temporary water system.

systems that serve buildings with sprinkler systems usually have 10-inch HDPE headers and 6-inch connections. The larger diameter temporary water systems are expensive and are often buried just below the surface at numerous places to allow access through the construction area. Recently, temporary water systems for residential areas have averaged \$23/foot and systems with fire flow capacity for business/commercial areas have averaged \$130/foot.

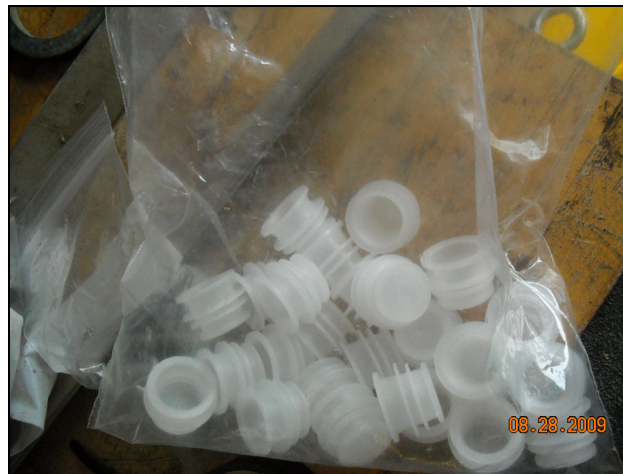
Figure 7. Water service plugs

Service reinstatement: Service connections of 2 inches and less in diameter are plugged with a plastic cap (Figure 7) before lining and are drilled out with a robotic cutter after the liner has been installed. Most of the water service connections in the AWWU system are constructed with threaded taps that protrude into the water main interior. Some saddles were used in the AWWU system for services larger than one inch. The taps have a higher reinstatement success rate. They protrude and are easier to find when covered with a liner and they have more consistent inside diameters that can better accept a temporary plug. Sometimes the robotic reinstatement is not successful for various reasons including: 1) the tap is covered with a shark-fin, 2) the tap does not show up well behind the liner and is difficult to accurately find, 3) the plug becomes dislodged during insertion or does not seal well against the tap or saddle, and resin leaks by and plugs the service pipe. In these cases the connection must be excavated and repaired. In Anchorage we have observed a success rate of approximately 95 percent for residential services, meaning on five out of 100 services the interior reinstatement is not successful and they must be dug up. In business areas with services at or larger than 1.5 inches, the success rate has been approximately 30 percent.

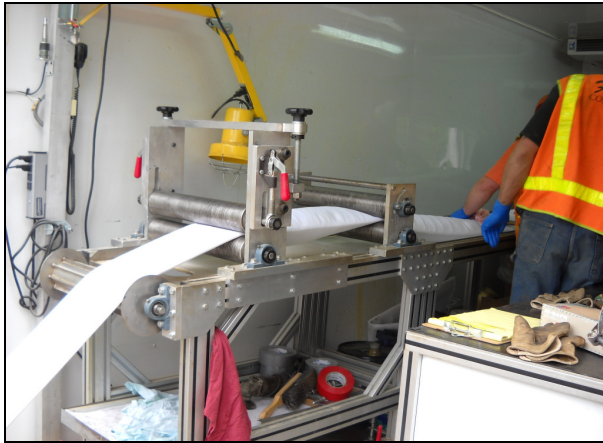
Figure 8. Wet-out and sizing equipment. Courtesy of Sanexen Aqua Pipe.

Liner installation: This process varies slightly depending on the liner manufacturer. The processes include 1) a wet-out phase when the fabric is impregnated with resin (Figure 8), 2) an inversion or pull in phase (Figure 9) and 3) a cure phase when the liner is pressed firmly against the host pipe and cures to full strength.

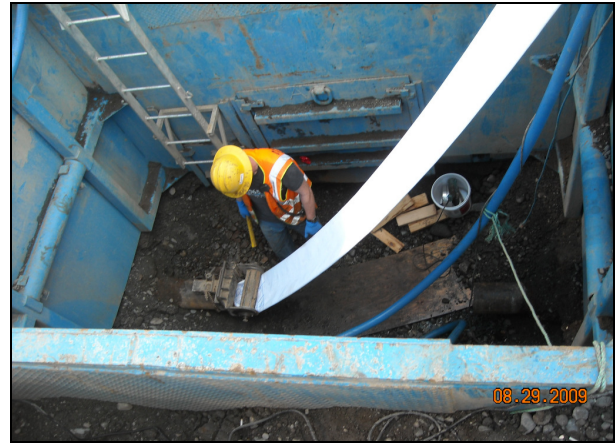
Figure 9. CIPP insertion into an AWWU cast iron main.
